Prop

Wash

August 2021

John's Nobler

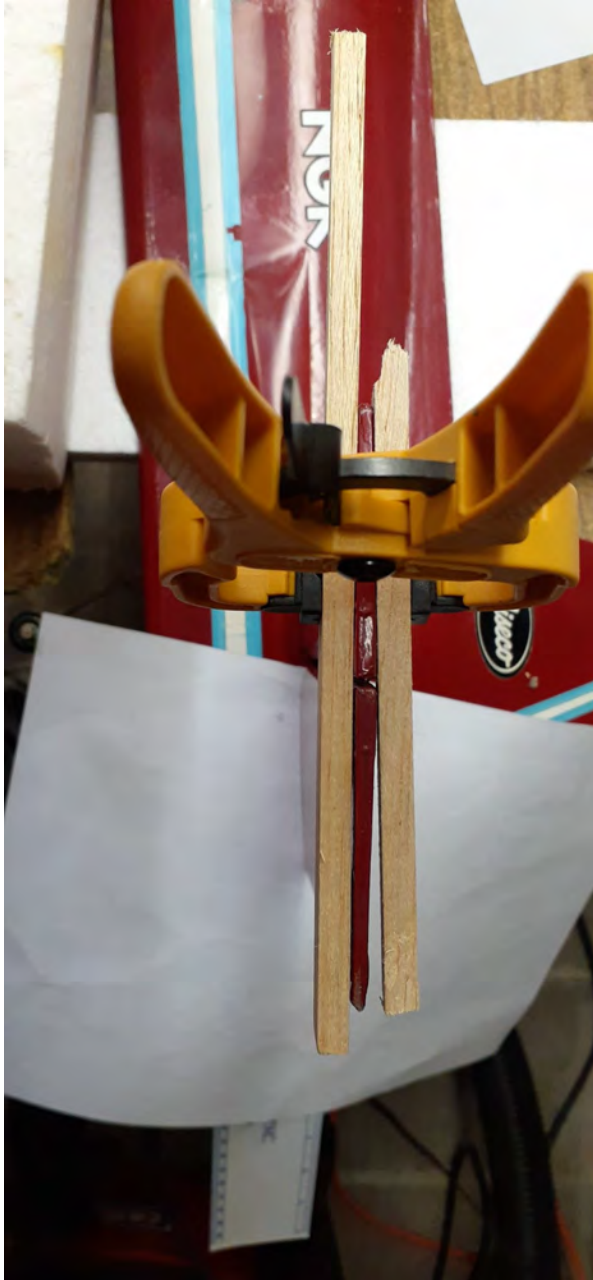
This is a followup to the article in Prop Wash about the Geiseke Nobler that I restored. On the first flight all I could do was to fly level laps as that was hard enough to do. I had to give a lot of up on the handle to keep the plane from making an early landing. To correct this problem I changed the handle to give some up control and the plane could fly level. Shame on me. I did not apply the KISS principle to the problem. I made the problem more complex than what it really was. The problem was that the elevator was about 3/32 " down when the flaps were at neutral. So much for a properly built plane.

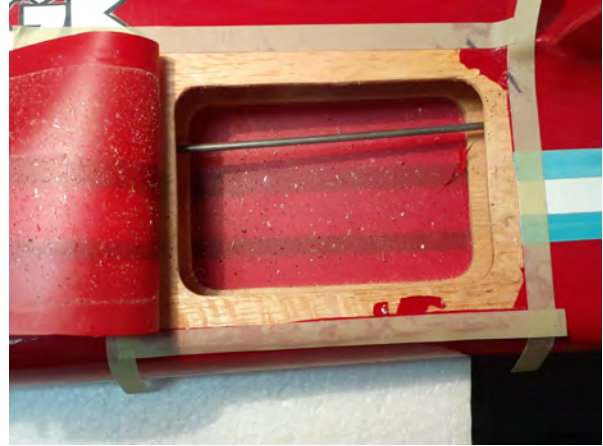
This problem off course needed to be corrected. Fortunately the plane had 2x3" holes in the fuselage. I cut open the plastic covering expecting to find a 3/32" Music Wire and was not disappointed. The Music Wire needed to lengthen to make the elevators go up.

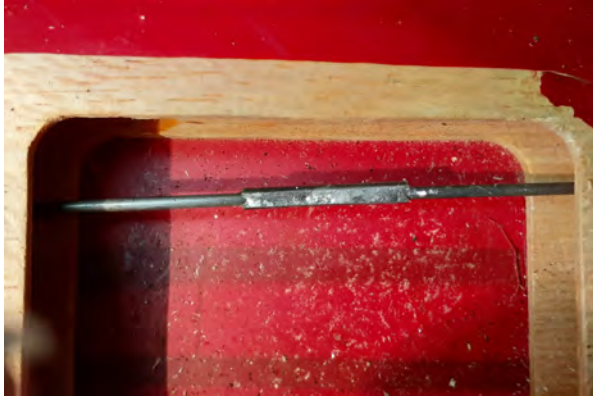
And it worked. The plane did not catch on fire. The elevators are now lined up correctly with the flaps.

I used epoxy to reattach the covering, as it is fuel proof and did not trust the covering to reattach using heat or even handle the heat from an iron. My first flight with this correction was just great. It was satisfying to find that the fix worked so well. The plane now is a better flyer. It is stable in flight but at the same time goes right where the handle is pointed.
